THE MNCWASA WATER SCHEME SURVEY PLAN

2 PURPOSE

The primary purpose of the survey was to capture all the current challenges/issues hampering water service delivery in the region. We have captured these below and intend to use the issues identified, together with remedial measures proposed to further engage ADM on a way forward.

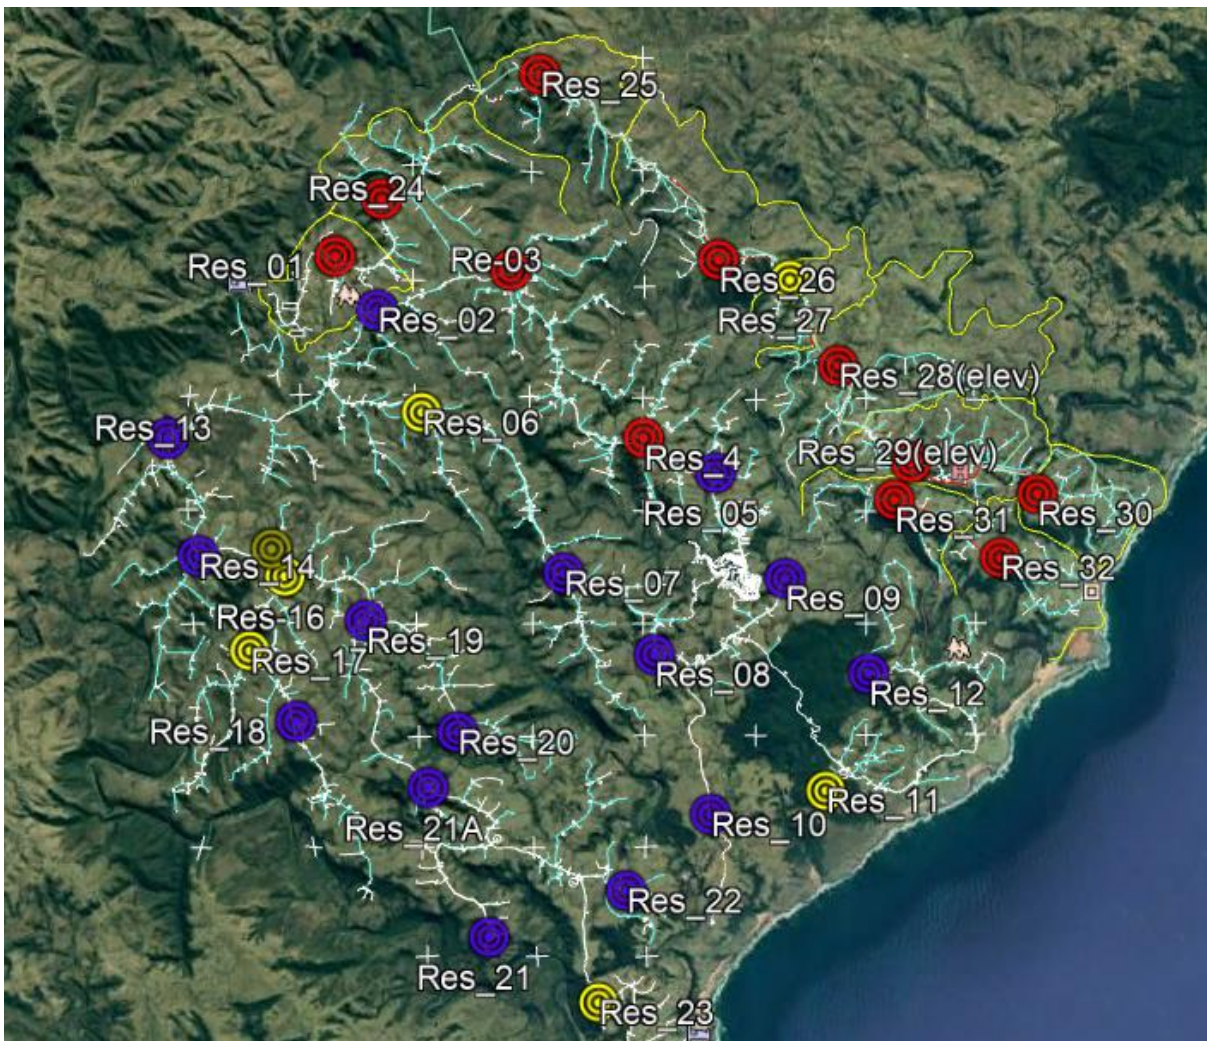
There is decreasing functionality as you move from south -south west (blue) to north - north east (red) across the scheme. The line across the scheme, and then down to Zithulele is clearly problematic.

- It is evident from the surveys that the availability and reliability of water decreases as you move from south -south west (blue) to north - north east (red) across the scheme. The line across the scheme, and then down to Zithulele is where the problem manifests itself. Please see engineer inputs below.

3. Judicious flow control within the scheme is required.
4. A second pipeline from the command reservoir, with its own outlet, to the Zithulele T-off, is recommended to ensure an equitable water supply to the Zithulele leg.

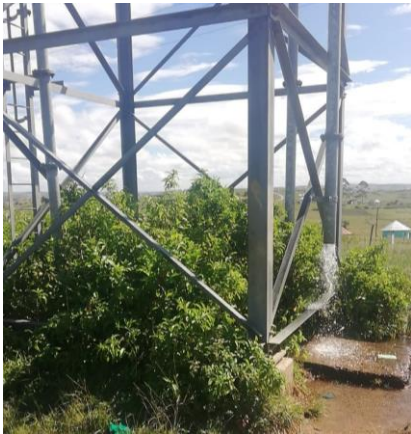
Res 15

Reservoir 15 and 21A were identified as overflowing. Both have already been reported to the municipality and resolved. These flow rates by observation are relatively high and significantly high in relation to the volume of water required by a village over a 24hour period. The overflowing here will impact supplies to all upstream villages.

1. This report be presented to the ADM for them to develop a comprehensive response thereto including:
 - a. Addressing all readily identifiable faults e.g., broken taps & reservoir/BPT control valves;
