THE MNCWASA WATER SCHEME SURVEY PLAN

2 PURPOSE

The primary purpose of the survey was to capture all the current challenges/issues hampering water service delivery in the region. We have captured these below and intend to use the issues identified, together with remedial measures proposed to further engage ADM on a way forward.

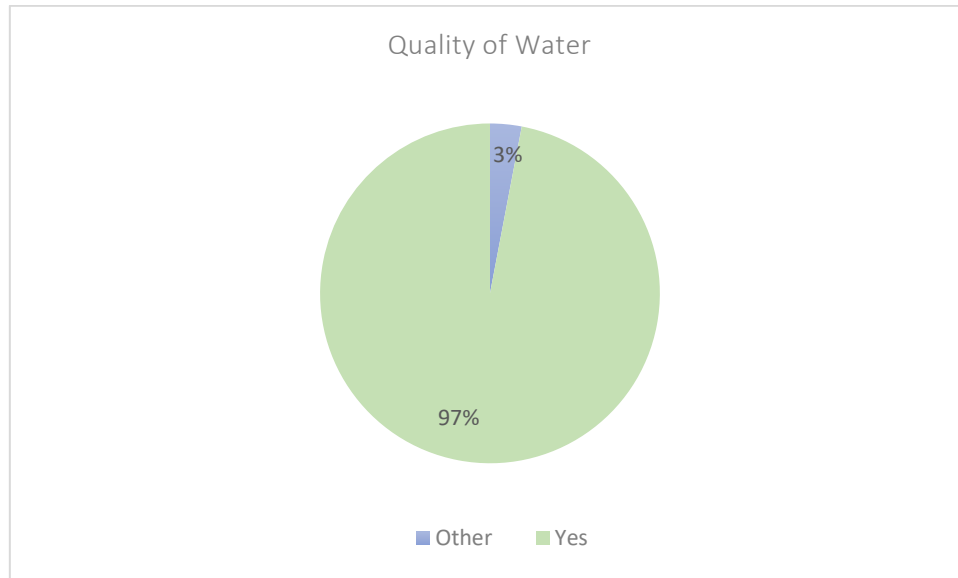
97% of the respondents noted that the quality of the water is good. The 3% (8 respondents) that indicated 'other', do not have access to taps.

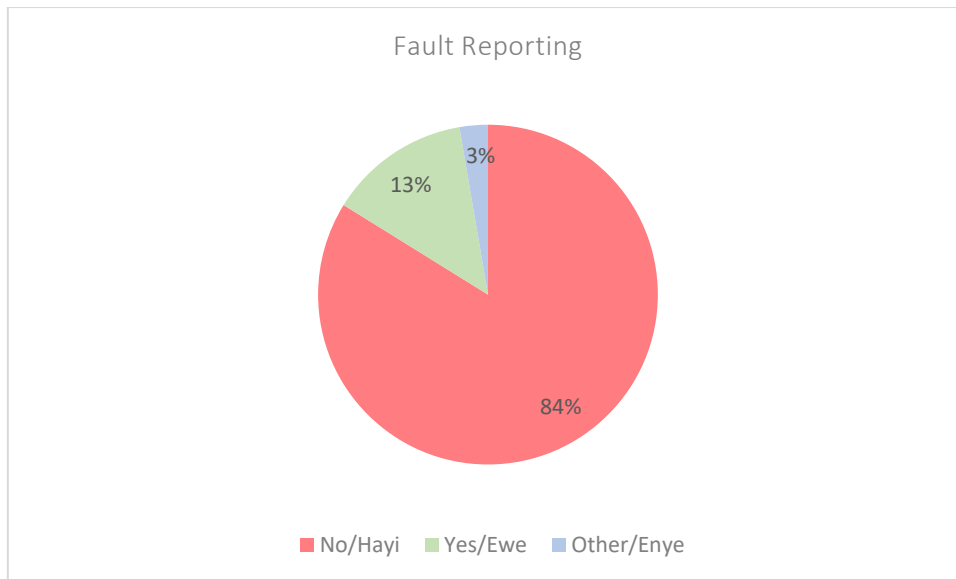
84% of respondents, the overwhelming majority, have never reported an issue regarding water, despite there being significant reliability issues. Only a small percentage, 13% have ever reported an issue. The 3% that indicated 'other' do not have access to taps.

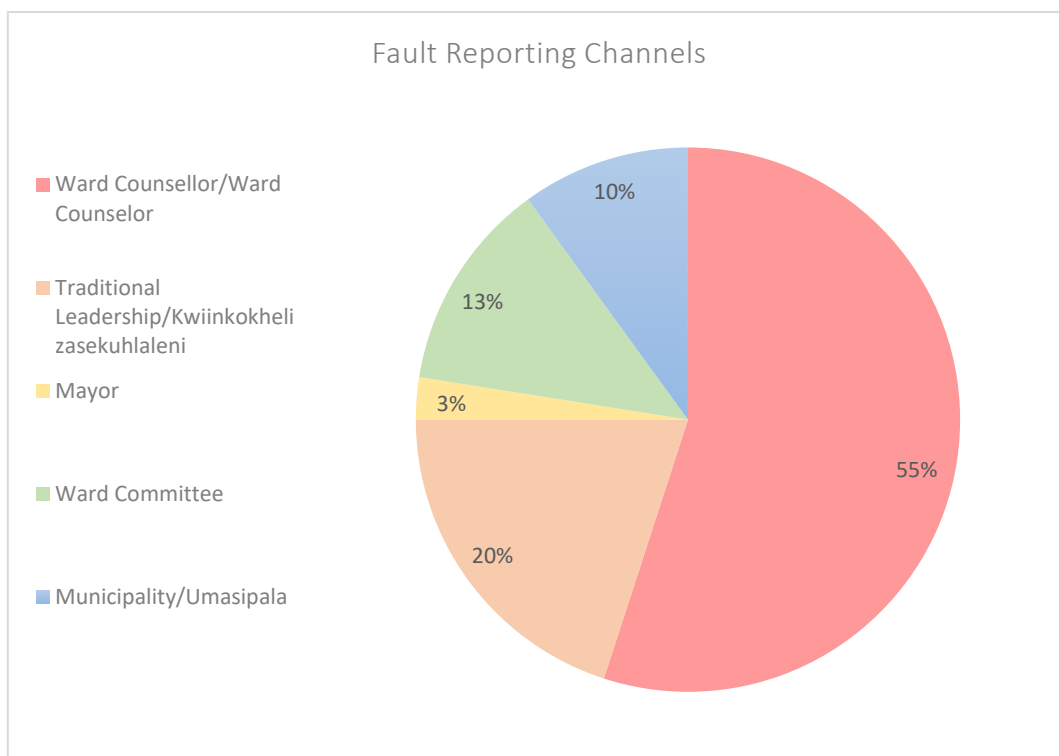
The 40 respondents that indicated 'yes' to reporting a fault, mainly reported issues to ward counsellors. The pie chart provides a breakdown of the fault reporting channels:

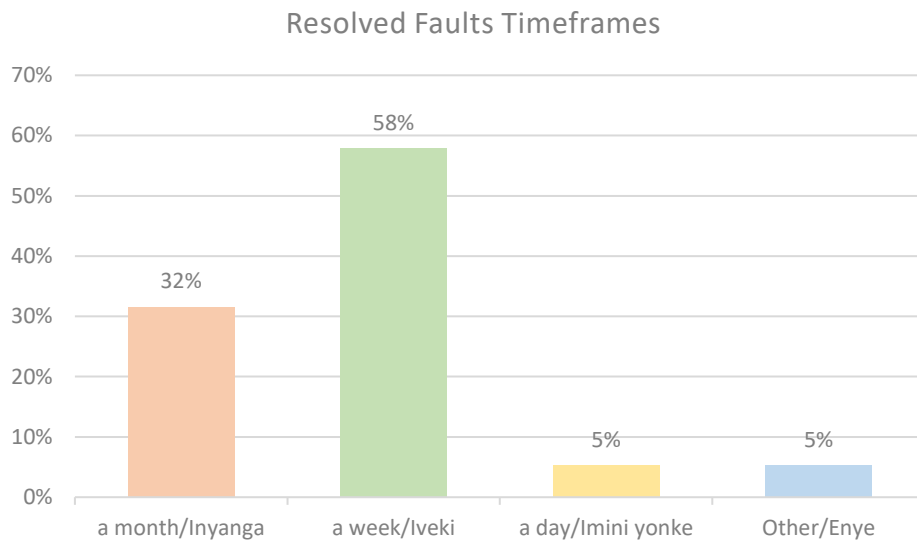
Out of the 40 respondents, just over half (53%) indicated that the faults are 'never' resolved. Of the faults that were resolved, more than half (58%) said it took 'a week' to resolve, while a third (32%) said it took 'a month' to resolve.
